Manhole Inspection Summary

Manhole # S45II_001MH

Insp Date: **6/19/08 10:18 AM**

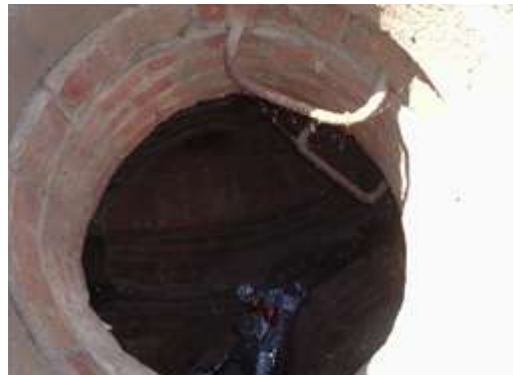
Defect 1

Infiltration

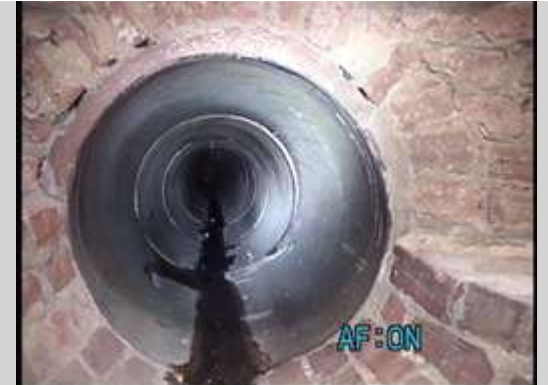
12 O'Clock Outflow

18 in. Circular Gravity Sewer
Pipe Out @ 12 O'Clock

Infiltration: **None** Pipe Seal Cond: **Sound**

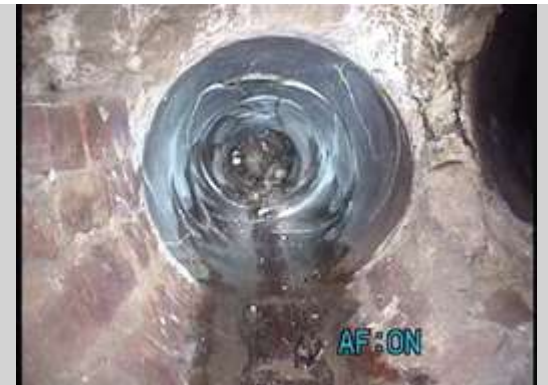
5 O'Clock Inflow

12 in. Circular Gravity Sewer
Pipe In @ 5 O'Clock

Infiltration: **None** Pipe Seal Cond: **Sound**

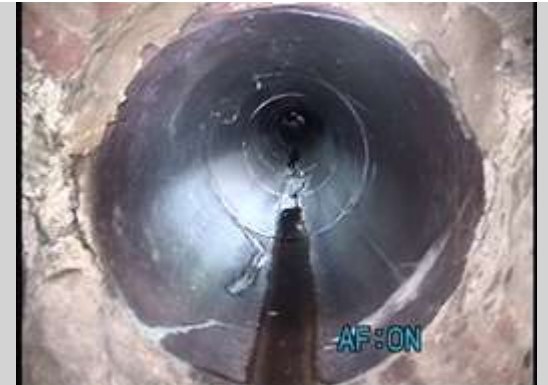
6 O'Clock Inflow

Infiltration: **None**

Pipe Seal Cond: **Sound**

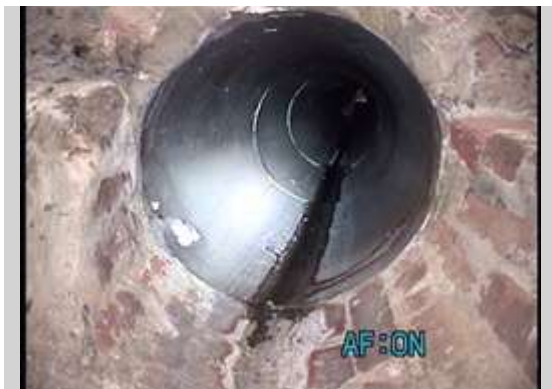
7 O'Clock Inflow

Infiltration: **None**

Pipe Seal Cond: **Sound**
